Suzuki Vitara
Supermini

2015

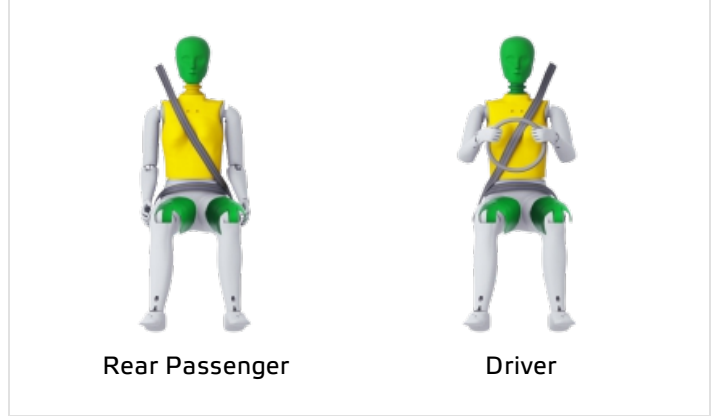
Frontal Full Width 7.7 Pts

Rear Passenger Driver

Detailed description: This panel shows the results for the Frontal Full Width test. It features two side-view illustrations of crash test dummies. The Rear Passenger dummy is primarily yellow with green sections on its legs, indicating an 'ADEQUATE' rating. The Driver dummy is primarily green with a yellow section on its right leg, indicating an 'ADEQUATE' rating.

The passenger compartment of the Vitara remained stable in the frontal offset test. The car scored maximum points for its protection of the passenger dummy in this test, with good protection of all body areas. Dummy readings showed good protection of the knees and femurs of the driver and passenger. Suzuki showed that a similar level of protection would be provided to occupants of different sizes and to those sat in different positions. In the full-width frontal impact, protection of the front passenger was good for all body regions except the chest, protection of which was adequate. For the rear passenger, protection of the neck and chest was adequate and that of the head and femurs was good. The Vitara scored maximum points in the side impact barrier test with good protection of all critical body areas. Even in the more severe side pole impact, protection was good for all areas and maximum points were scored. Tests on the front seats and head restraints showed good protection against whiplash injury in the event of a rear-end collision and a geometric assessment of the rear seats also indicated good protection. The Vitara has an autonomous emergency braking system which operates at the low speeds typical of city driving. However, as the system is not standard equipment, its AEB City functionality did not qualify for inclusion in the assessment.

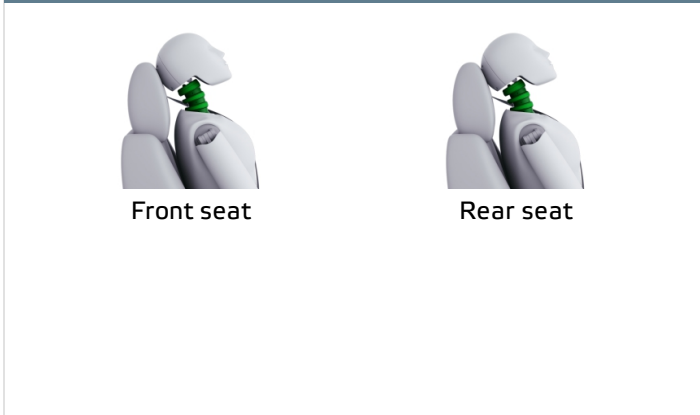
Whiplash Rear Impact 2.7 Pts

Front seat Rear seat

Detailed description: This panel shows the results for the Whiplash Rear Impact test. It features two rear-view illustrations of a car seat headrest and neck area. The Front seat illustration shows a green neck area, indicating a 'GOOD' rating. The Rear seat illustration shows a yellow neck area, indicating an 'ADEQUATE' rating.

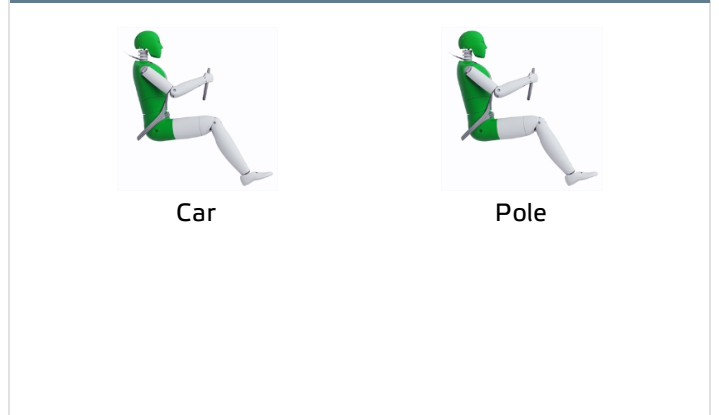
Lateral Impact 16 Pts

Car Pole

Detailed description: This panel shows the results for the Lateral Impact test. It features two side-view illustrations of a crash test dummy. The Car illustration shows a green dummy, indicating a 'GOOD' rating. The Pole illustration shows a green dummy, indicating a 'GOOD' rating.
